HOUSATONIC RIVER BASIN
DANBURY, CONNECTICUT

MARGERIE LAKE RESERVOIR DAM
CT 00063

PHASE I INSPECTION REPORT
NATIONAL DAM INSPECTION PROGRAM

DECEMBER 1978

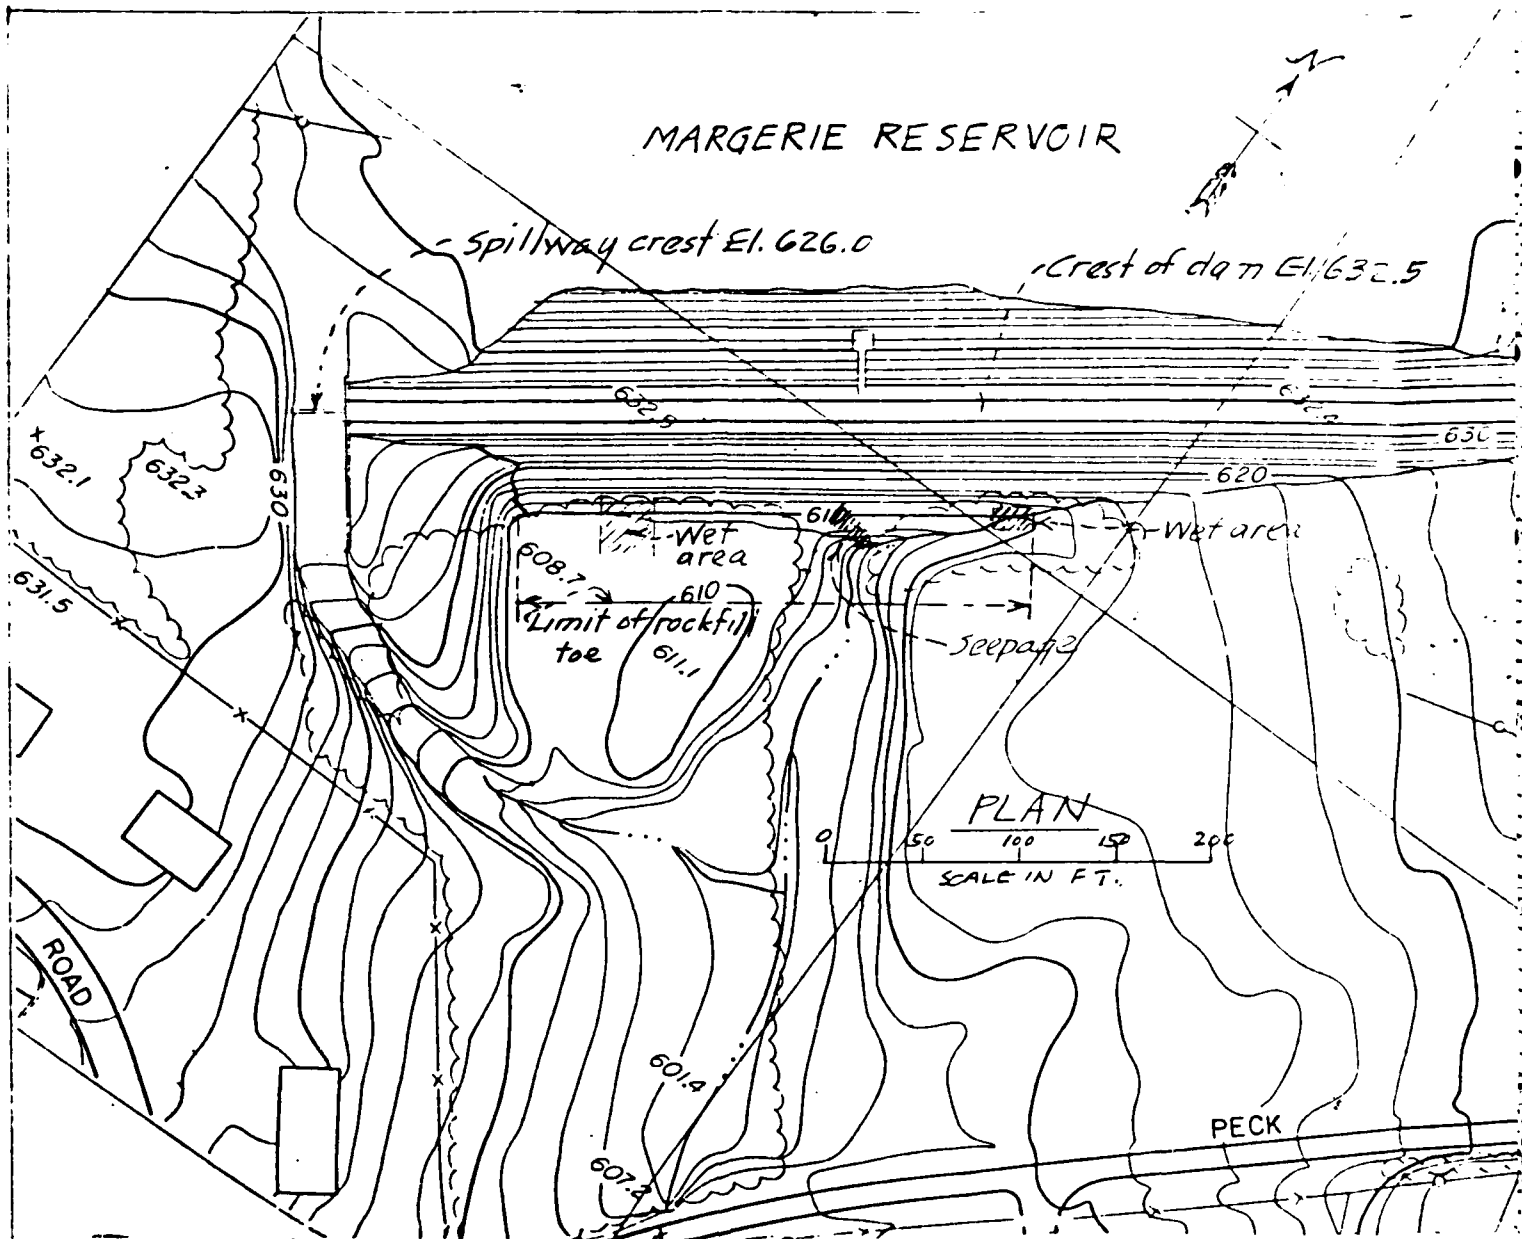
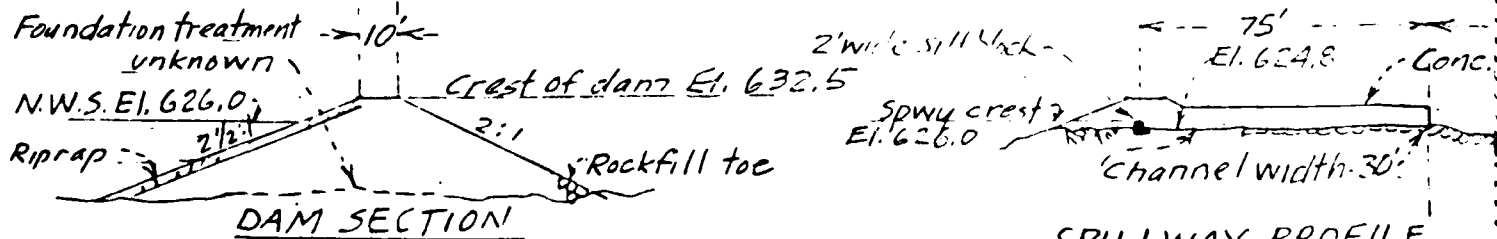
Seepage Three locations at downstream toe of main dam as noted on Figure 1.

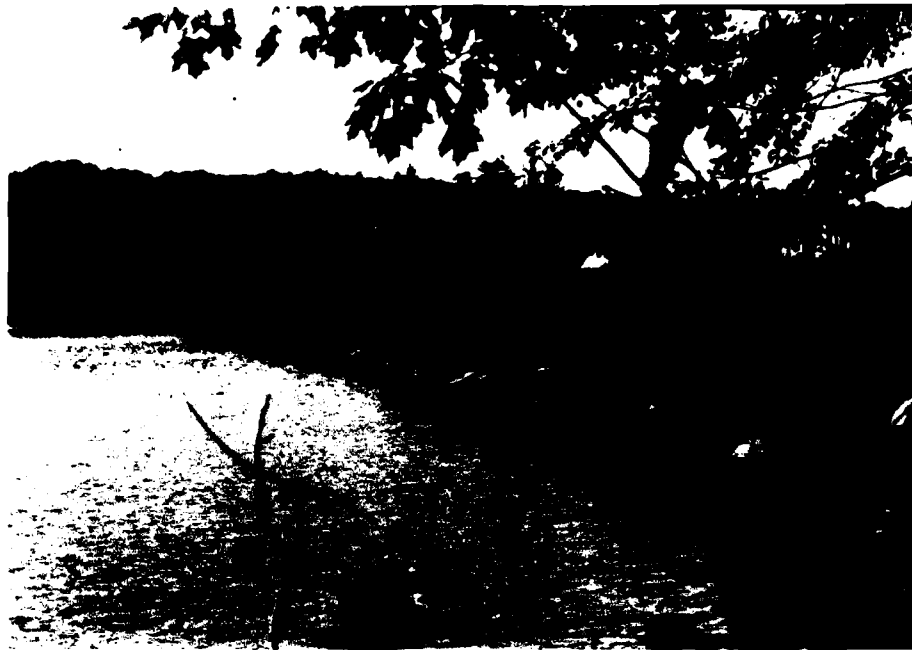
3. Upstream slope of north dike from right abutment.

3. Two small chuckholes in the main dam approximately 40 ft. left of the spillway left training wall should be filled.
4. Riprap missing on the upstream slope of the north dike should be replaced in the area adjacent to the earth ramp near the center of the dike.
